## GATE REHABILITATION AT EXISTING HYDROELECTRIC PROJECTS

BY THOMAS L. KAHL, P.E., KLEINSCHMIDT ASSOCIATES, PITTSFIELD, MAINE, USA

### **EXAMPLE ONE – MIDDLESEX SLUICE GATE**

## **EXAMPLE 2 - VERGENNES INTAKE GATES**

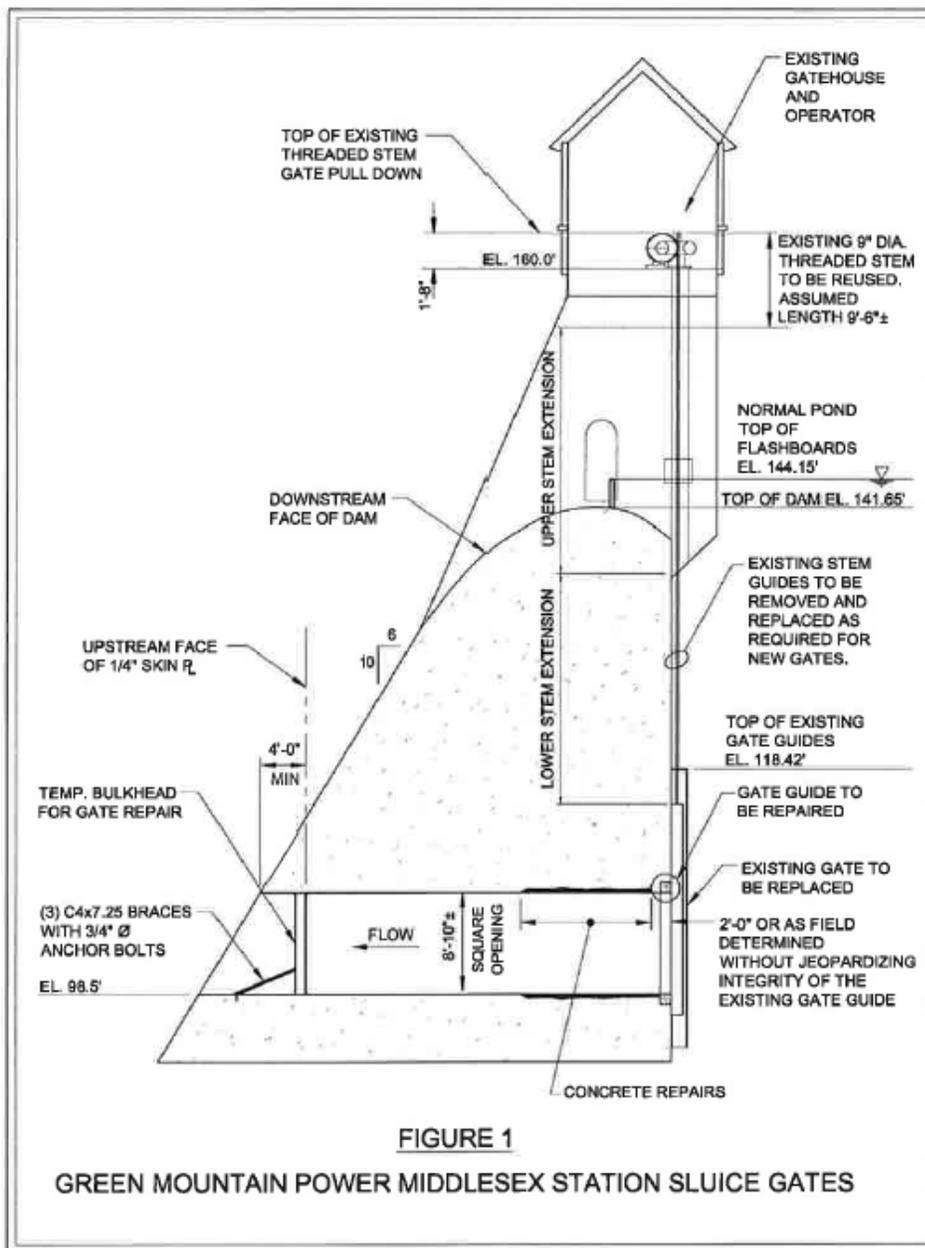
As shown in the spillway cross section shown in Figure 1, these gates did not have any provisions for dewatering bulkheads, probably because when this spillway was built in 1929 it was envisioned that the headpond could simply be drained during low river flows. But changes in societal environmental aesthetics since then makes it currently impossible to obtain permits to

simply open the gates and completely drain the headpond. This necessitated that replacing the gates would require some method of cofferdamming. During initial project planning in the fall of 2001 three options of installing a cofferdam in a suspected shallow area approximately a half mile upstream of the spillway, adapting an abandoned upstream timber crib dam used to cofferdam for the original 1928 spillway construction, and installing a braced sheet pile cofferdam on the upstream face of the gate openings. Because the first two options resulted in dewatering the gorge they were found to present significant permitting difficulties. The deep water and steep rock gorge profile upstream of the spillway made the third option very difficult technically and expensive with an estimated cost in the \$150,000 to \$200,000 range.

Then GMP along with the project team of Kleinschmidt Associates as the design engineer and Fairbanks Mills of St. Johnsbury Vermont as the contractor conducted a joint inspection of the gates in early December 2001. Significant concrete deterioration behind the gates guides was discovered in the sluice tunnels. Also during this visit the team collaboratively formulated a new cofferdam alternative. As shown in Figure 1 it consisted of using a downstream tunnel bulkhead that would allow the gates to be removed without having to install an upstream cofferdam. Additional benefits were that it simplified permitting by eliminating any need to lower the headpond water elevation during the project, did not interfere with normal station operation, and was significantly less expensive than a traditional upstream cofferdam.

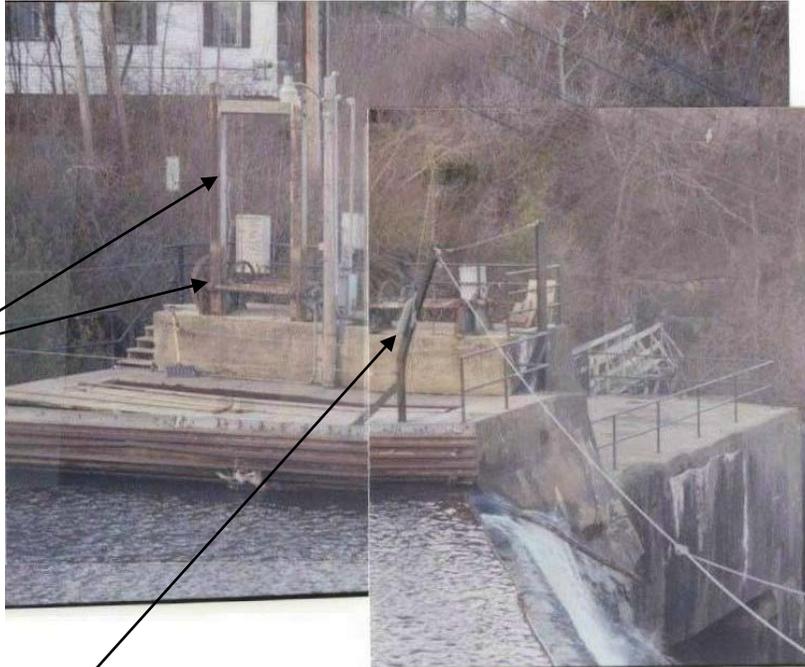
PHOTOGRAPH NO. 1

In December 2001 one of the wooden gate stems on Gate No. 1 broke suddenly while the gate was being lifted. Photograph No. 1 shows the intake with the original rack and pinion operators in December 2001. Both gates are in the full up position showing the gate rack stems for Gate No. 2. The broken stems for Gate No. 1 on the right have been removed. Photograph No. 2 shows the detail of the broken stem, where wood decay had reduced the stem's load carrying cross section below the limit that could carry the gate reactions. Although Gate No. 1 was able to be lifted and temporarily secured by using a come-along attached to cables looped through the filler gate, it was obvious that because this station would not be renovated in the foreseeable future, both gates and operators needed to be replaced.

GATE NO. 2  
ORIGINAL RACK  
AND PINION  
OPERATORS WITH  
GATE FULL UP.

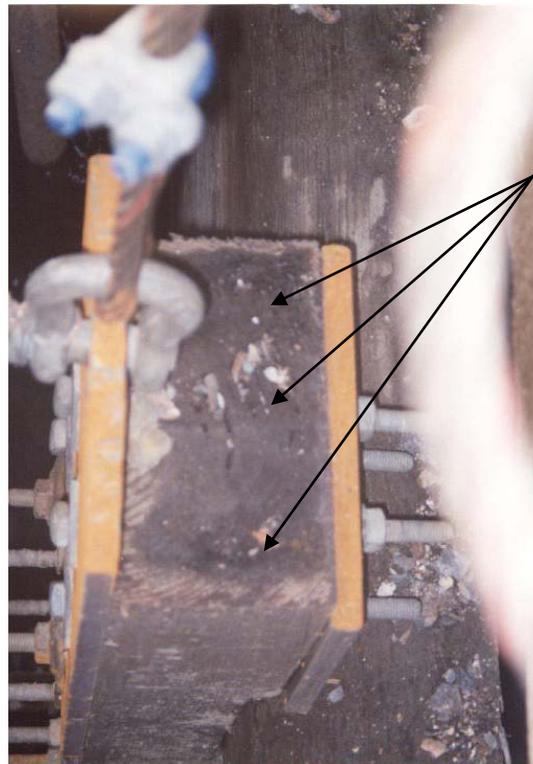
PHOTOGRAPH NO. 2

GATE NO. 1  
FULL UP AND  
BROKEN RACK  
STEM REMOVED.

DETAIL OF BROKEN  
GATE NO. 1 STEM.  
DARK AREAS SHOW  
DECAYED WOOD  
WHERE STEM SEVER  
INITIATED.

Because these shallow gates are used only a few times a year for turbine maintenance dewatering, it was determined that they would be simple slide gates operated by a standard monorail supported electric hoist. GMP decided to reduce project costs by installing the new gates with in-house maintenance personnel. The intake deck is very congested, and the monorail supports and gate access required some reconfiguring of access stairs and platforms. Also it was important that the monorail supports be placed where the lightly reinforced concrete intake is structurally adequate. This intake's structural adequacy was determined through a combination of site inspection and a review of original 1920 vintage intake rebar drawings.
