POTENTIAL FAILURE OF WEST GRAND LAKE DAM DIAGNOSING AND AVERTING AN IMMINENT FAILURE

MR. DAVID B. NASH, P.E., KLEINSCHMIDT ASSOCIATES, PITTSFIELD, ME, USA

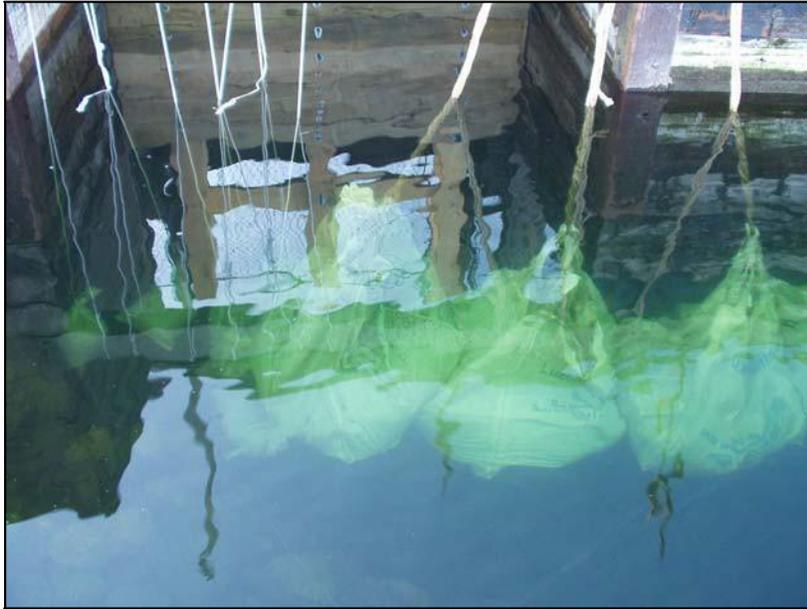
During the course of this inspection, several “hot spots” were detected along the cut-off location as well as along an existing concrete training wall between the gate structure and fishway. Sheet plastic was submerged with small sand bags over the suspect areas. Additionally, the contractor placed one cubic yard sized bulk grain bags on the areas of most concern.

SANDBAGS FILLING VOIDS UPSTREAM OF GATE APRON

The temporary measures were effective at reducing the flow to a more tolerable level by 5:00 p.m., however nine inches depth of flow was still passing through the gate area. The conclusion was that the project was in an emergency condition. The Emergency Action Plan (EAP) notification flow chart was partially enacted, regional agencies were notified and informed that investigation was underway, and a security guard was put on 24-hour alert.

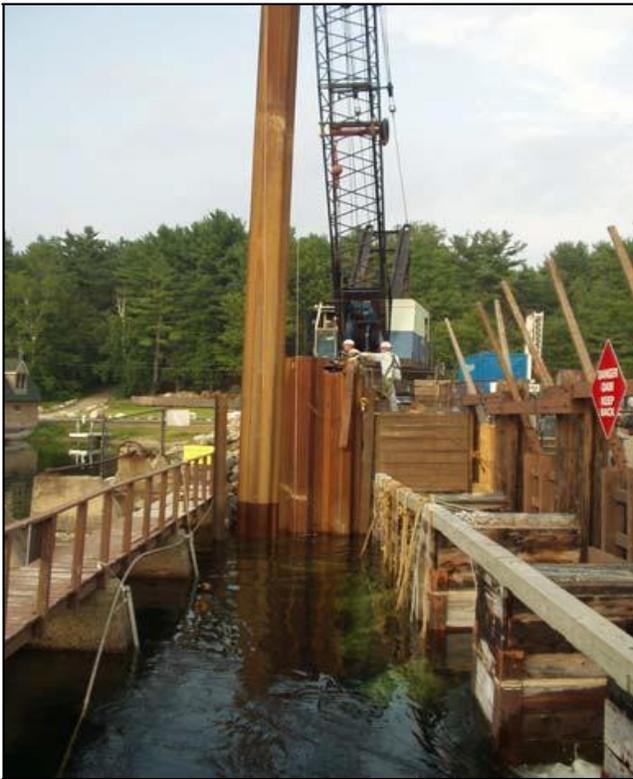
INSTALLATION OF PHASE I COFFERDAM AGAINST EASTERN ABUTMENT

The design concept was to drive a steel sheetpile cofferdam in two phases creating a dry work space to conduct demolition and replacement activities. The plan called for extending the sheetpile cofferdam into the embankment to create a seepage path long enough to prevent future piping. Both phases included closure seals at each end. Additionally, all work was to be performed behind the cofferdam, allowing the placement of concrete in the dry. Phase I enclosed gate bays 3, 4, and 5. Phase II enclosed gate bays 1 and 2.

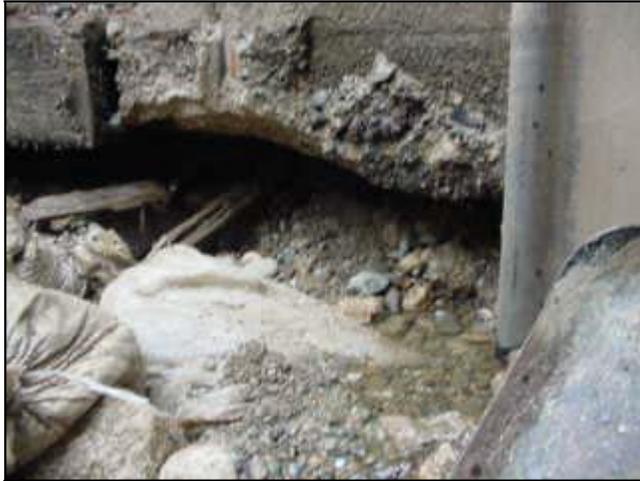
Upon dewatering the Phase II cofferdam, a huge void was found under the existing concrete training wall that separated the fishway from the gate structure.

**VOID UNDER EXISTING CONCRETE TRAINING WALL DISCOVERED DURING DEWATERING
NOTE EMBEDDED SAND BAGS.**

It was determined that water entering beneath the concrete wall was the major contributor to the leakage at gate bay five. Water apparently had entered from one side of the gate structure and exited the opposite. The flow was passing under the apron by way of the open cribwork totally masking the source of the problem area.

The wall was completely removed and the concrete apron was placed up against the sheetpile cutoff wall. A new concrete training wall was poured on top of the apron, re- establishing the separation between the fishway and the gate structure.

The installation of a steel sheet cutoff across the entire gate and fishway structure essentially eliminated the future concern for piping beneath the gate structure. To aid in future observations and maintenance of the structure, two stand pipes were installed and an under drain discharge pipe. The standpipes will be used to monitor any uplift beneath the concrete gate apron that would indicate excessive underflow building uplift. The under drain discharge pipe exits on the downstream side of the gate structure and provides a visual observation of the leakage. The discharge pipe is a four inch PVC pipe that is only flowing partially full. Remember the underflow/leakage that we started with was eighteen inches deep over a width of nine feet, not to mention other bay leakage and pier leakage. As can be seen from the reduction in leakage down to a small weeper pipe, the success of this project speaks for itself.

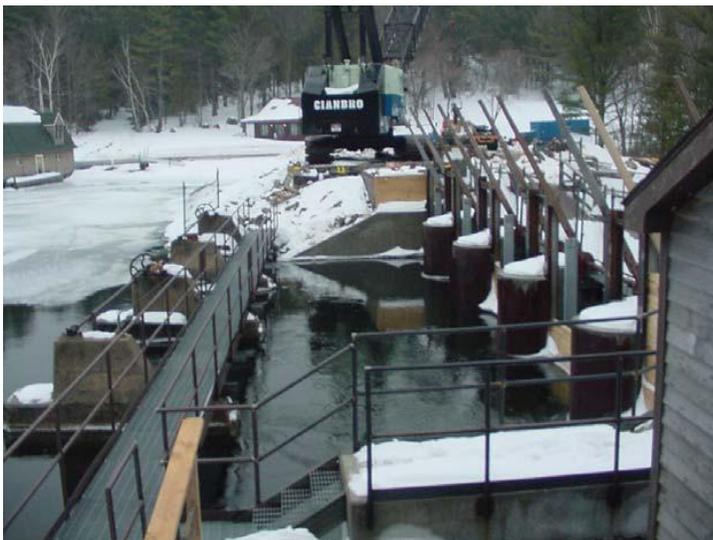
COMPLETED PROJECT
