HARDY UNIT NO. 3 TURBINE REHABILITATION

DAVID MCINTOSH¹, DOUG CHERWINSKI², THOMAS KAHL³

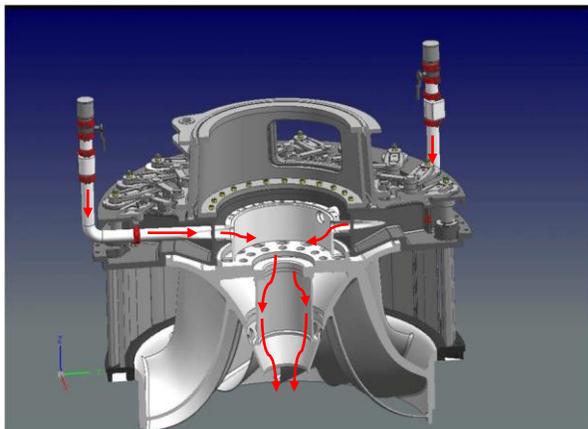
The figure below shows a graphic cross section of AHC's new runner illustrating the turbine venting system that incorporated modifications to the existing head cover to mate with the new runner. The original head cover was modified with the addition of a header with four air lines. Operation of the aeration system is very simple and consists of opening the butterfly valves allowing the natural draft tube vacuum to draw atmospheric air from the dry turbine pit through the inside of the runner crown and holes in the runner nose cone where it enters the draft tube and is mixed with the turbine's discharge.

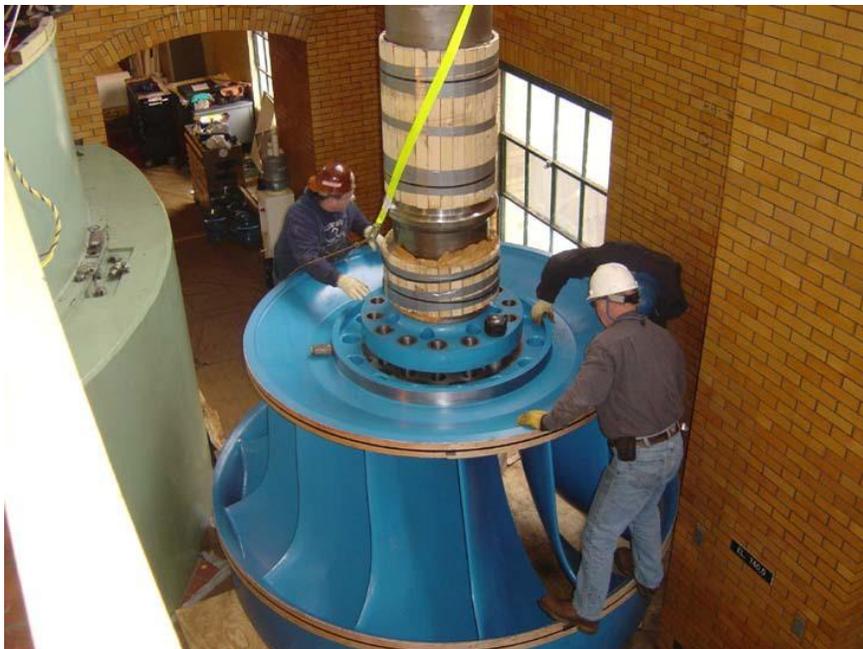
The turbine reassembly began in earnest on December 3, 2008. The figure below shows the new runner delivered to the site before assembly.
