MARSHFIELD STATION REHABILITATION

BY MATTHEW DUNLAP P.E., KLEINSCHMIDT ASSOCIATES

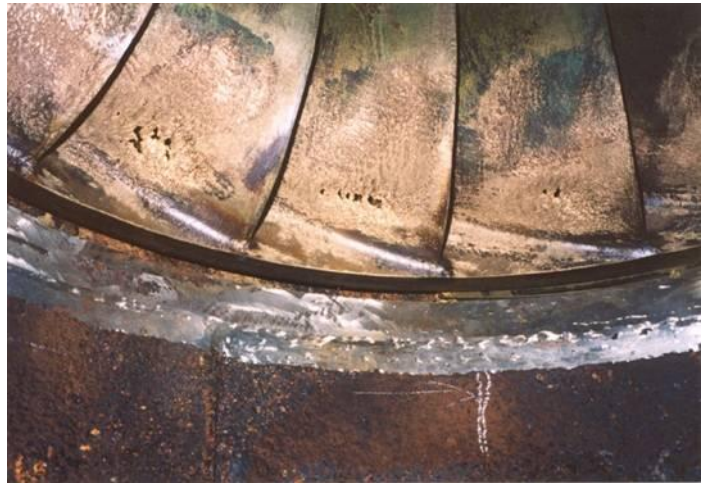
Within two days of the occurrence and after dewatering the 8,300 ft long penstock, Kleinschmidt and GMP personnel were able to inspect the high pressure side of the turbine from the scroll case and the low pressure side of the runner and the discharge ring from a draft tube maintenance platform. The initial observation was that runner cavitation had not only produced the characteristic surface pitting or “frosting” on the runner’s low pressure trailing edge but had been so prolonged and excessive that it precipitated the complete penetration of the buckets on almost all blades as shown in Photo 2.

The uniform cavitation indicated that there was an initial design problem with the runner and that the condition was not due to local manufacturing or casting imperfections. However, with this type of wear it becomes more difficult to isolate the fundamental cavitation source whether it be the operation of the unit, operating heads, or blade profile. Historical investigation disclosed that the original equipment had been intended for another site, but after the original site’s construction was postponed the unit had been installed at Marshfield and operated under slightly different operating conditions. This appears to have been a contributor to the cause of cavitation.

PHOTO 2 RUNNER BUCKET EROSION

One “rule of thumb” states that runner cavitation repair should be undertaken when damage is approaching 20 percent of the blade thickness or 1/2” in depth although most owners elect to perform the repairs when the damage reaches a maximum depth of around 3/8” which is the depth that can be filled with two weld passes.¹ Since this was a bronze based runner the weld filler would typically be an Ampcotrode 10 aluminum bronze filler which would provide a significant improvement in cavitation resistance.² However, since the damage had obviously exceeded those conditions and since modification of the existing profile to prevent future cavitation would be somewhat a trial and error procedure, it appeared best to replace and not repair the runner.

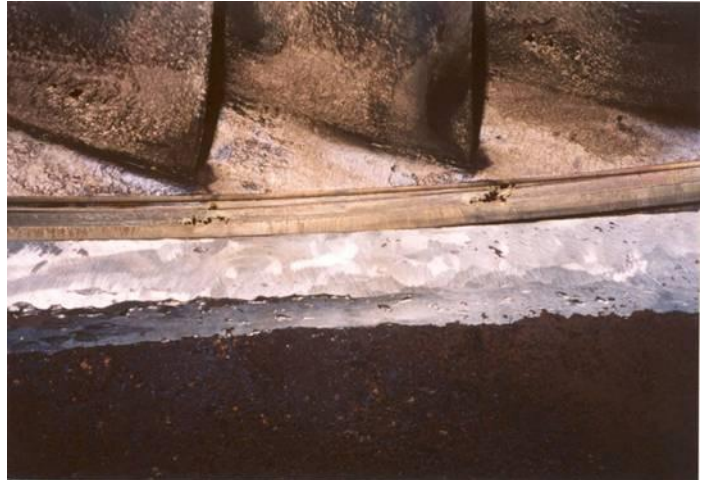
The additional vibration mentioned previously and the condition of the generator shaft mentioned later had also forced the runner’s rotating bronze seal ring to wear against the stationary seal ring to the point that the rotating ring had worn completely through at one location.

Correspondingly, the seal ring pins had become so corroded that the combined effects of the worn ring and the weakened pins caused the seal ring to detach (see Photo 3 above) creating tremendous equipment vibration. Not only had the failure created vibration but, because of the increase seal clearance, high pressure water was able to bypass the runner buckets. The bypassed

PHOTO 3 DETACHED SEAL RING

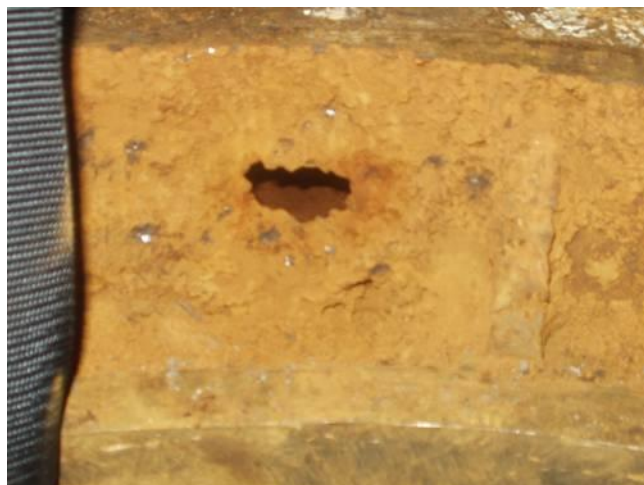
PHOTO 4 DISCHARGE RING CONDITION

water cavitated because of the abrupt change in pressure causing 5/8" deep cavitated pockets in the embedded discharge ring and in some locations completely penetrating the steel ring and eroding the foundation's concrete (Photo 4). It is recommended that periodic inspections (not necessarily annually) of the runner's seal clearance be performed to prevent such damage and to maintain efficiency.

To begin repairing the unit, the voids in the concrete behind the discharge ring were filled with a cementous grout. Then the remaining gusset brackets and the remaining circumferential material were machined to sound material; whereupon weld overlays were built up concentrically with new gussets installed. This process was found to be, in this instance, less expensive and far quicker to incorporate than machining and installing filler pieces.

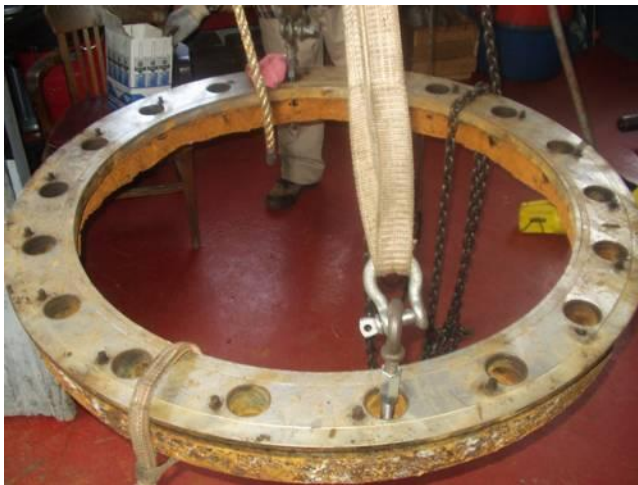
PHOTO 5 LOWER CURB RING

As the unit was disassembled the extent of the damage became more evident. The stainless steel wicket gate facing surface of the lower curb ring appeared to be in excellent condition from the scroll case vantage point (Photo 5); however, as seen in Photo 6, the cast steel lower base, which had been hidden by the runner's lower band, was extremely eroded to such an extent that the wicket gate bearing journals were exposed thus damaging the wicket gate stems. Therefore the stainless steel portion was retained while a new lower base was to be supplied.

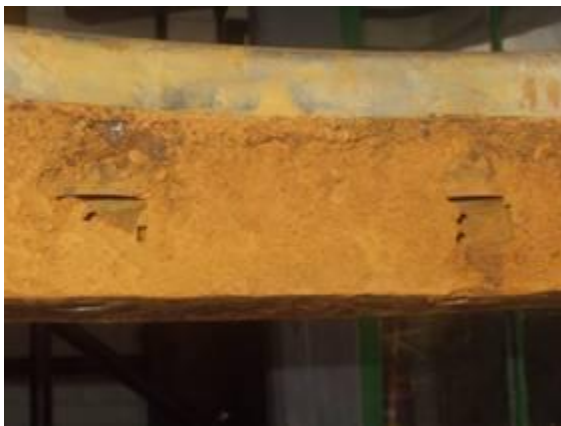
PHOTO 6 EXPOSED WICKET GATE BUSHINGS

Due to the wicket gate bushing condition, new wicket gates were supplied and the original bronze bushings were replaced by Tenmat FEROFORM® T814. This material consists of a cured phenolic resin matrix carrying reinforcing fibres and which has been advertised as being used in over 1,500 turbines. The operating linkage/wicket gate thrust rings and all linkage bushings were replaced with Delrin AF, which according to its engineering data has a 13,000 psi compressive strength, a Rockwell hardness number of R120, and a dynamic coefficient of friction of 0.14. Both materials have operated successfully to date, but have not been disassembled for inspection.

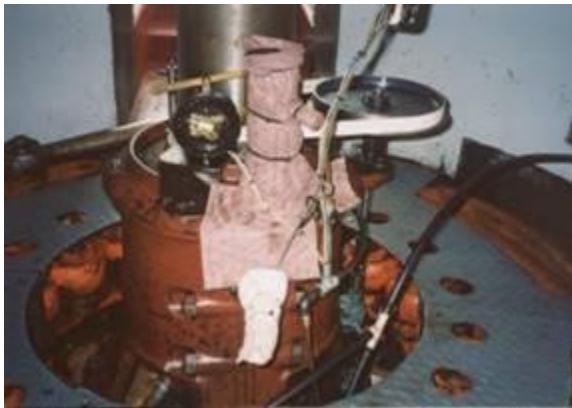
Additionally all Babbitt guide bearings and the spring based thrust bearing were damaged, with large pieces of Babbitt missing from the guide bearings and 40% to 50% of the Babbitt not bonded to the base of the thrust bearing. GMP elected to install a new Craft roller bearing to replace the previous oil-lubed Babbitt bearing to simplify both the system and its maintenance. The new Craft bearing, which is rated for operation in a submerged environment, has performed remarkably well considering the vibrations that occurred after the unit was re-commissioned (discussed below). Had a Babbitt bearing been installed, the bearing surface would have needed to have been remachined as was necessary for the generator's lower guide bearing and would have added significant time to the turbine repairs.

PHOTO 8 ORIGINAL TURBINE GUIDE BEARING INSTALLATION

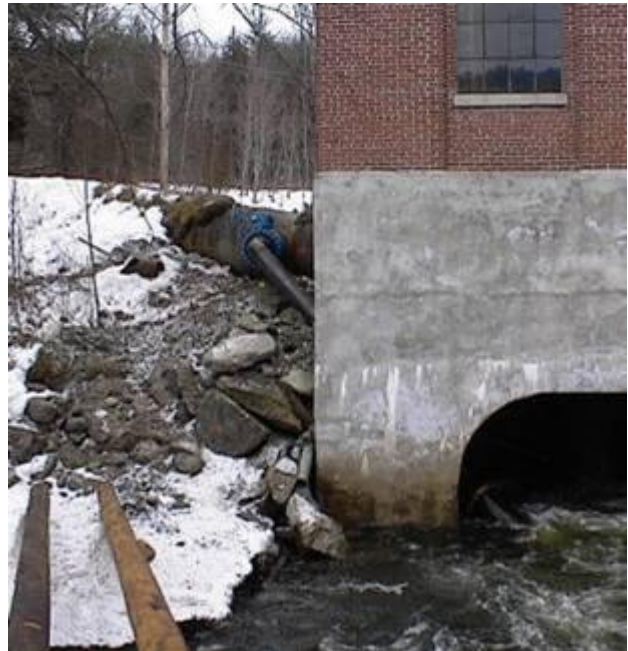
PHOTO 10 TURBINE BYPASS

A turbine bypass at the powerhouse was required to address both the freezing and flooding concerns. The bypass had to be extracted upstream of the turbine's butterfly valve, located inside the powerhouse, to allow continued work on the unit, but had to be discharged within the footprint of the powerhouse to comply with state permit concerns. Thus the exposed steel penstock was to be tapped and bifurcated just upstream of the powerhouse. A valve would be installed just downstream of the bifurcation with the discharge pipe angled down a newly cored 18" diameter hole through the powerhouse foundation.

Typically the valve downstream of the bifurcation would have to be a Multiple Orifice Valve designed to dissipate the full 350 foot of potential energy; however, this type of valve required an unacceptable delivery time. Therefore, Kleinschmidt located the most readily available surplus ball valve and, using a finite element vibration analysis and detailed flow calculations, designed an energy diffusing chamber capable of reducing the potential free discharge velocity from approximately 95 fps to 30 fps. This diffusion chamber was bolted to the furthest downstream portion of the pipe underneath the powerhouse and discharged into the same bay where the conical draft tube discharged (Photo 10).
