MARSHFIELD STATION REHABILITATION

BY MATTHEW DUNLAP P.E., KLEINSCHMIDT ASSOCIATES

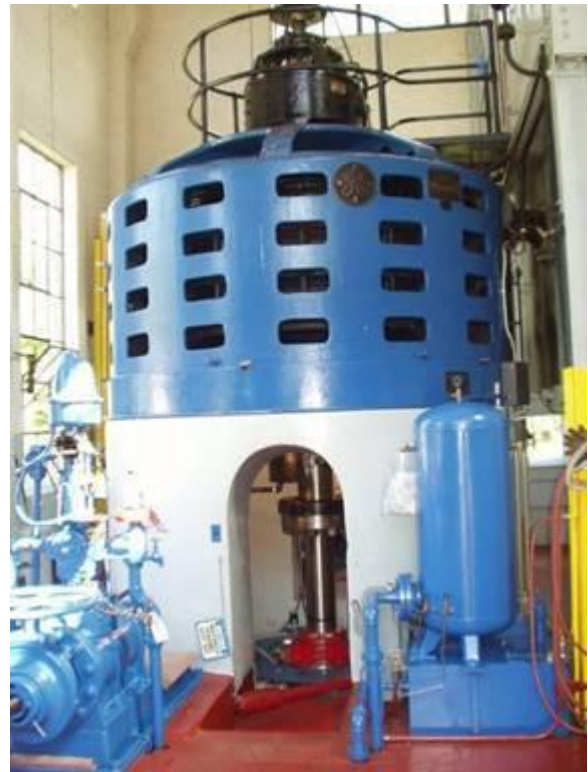
PHOTO 11 MARSHFIELD REFURBISHED TURBINE

Since June 2005 the Marshfield hydroelectric generating unit continues to operate without any restrictions or problems and continues to provide greater power production that had been possible before the rehabilitation.
